Arroyo Grande Creek Channel Waterway Management Program

National Marine Fisheries Service
Biological Opinion Annual Report

January 2026

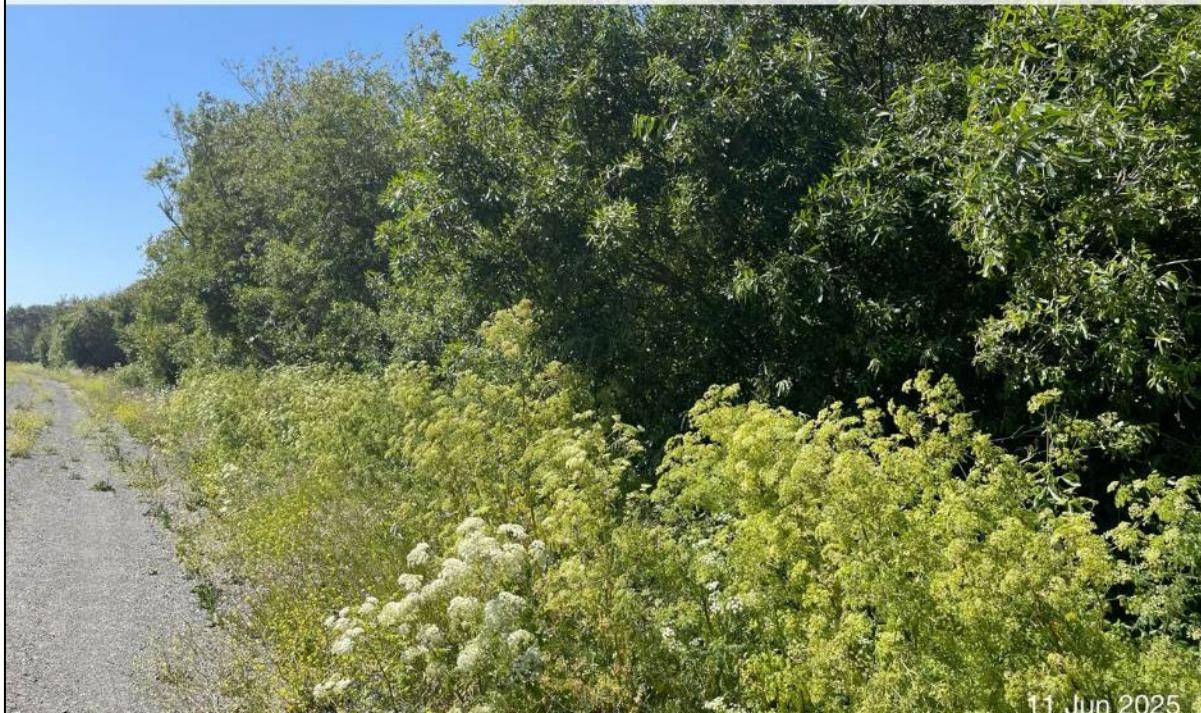
Photograph 4. View of SMZ 2, facing northwest. June 11, 2025.
