**Project Name  
(as found on  
Certification):** Arroyo Grande Creek Channel Waterway Management  
Program

# Arroyo Grande Creek Channel Waterway Management Program

Regional Water Quality Control Board,  
Certification No. 34012WQ01 Annual Report

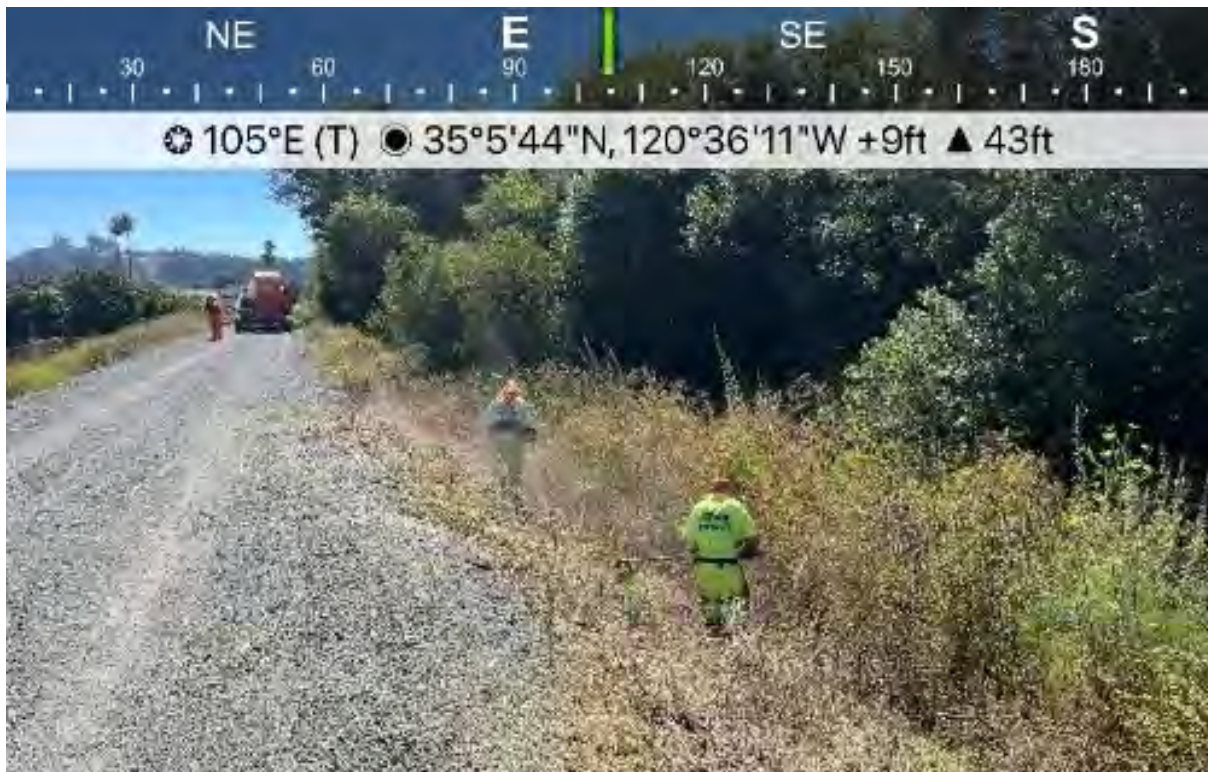
**Photograph 1.** Vegetation removal at SMZ 12/13, facing east. July 10, 2025.

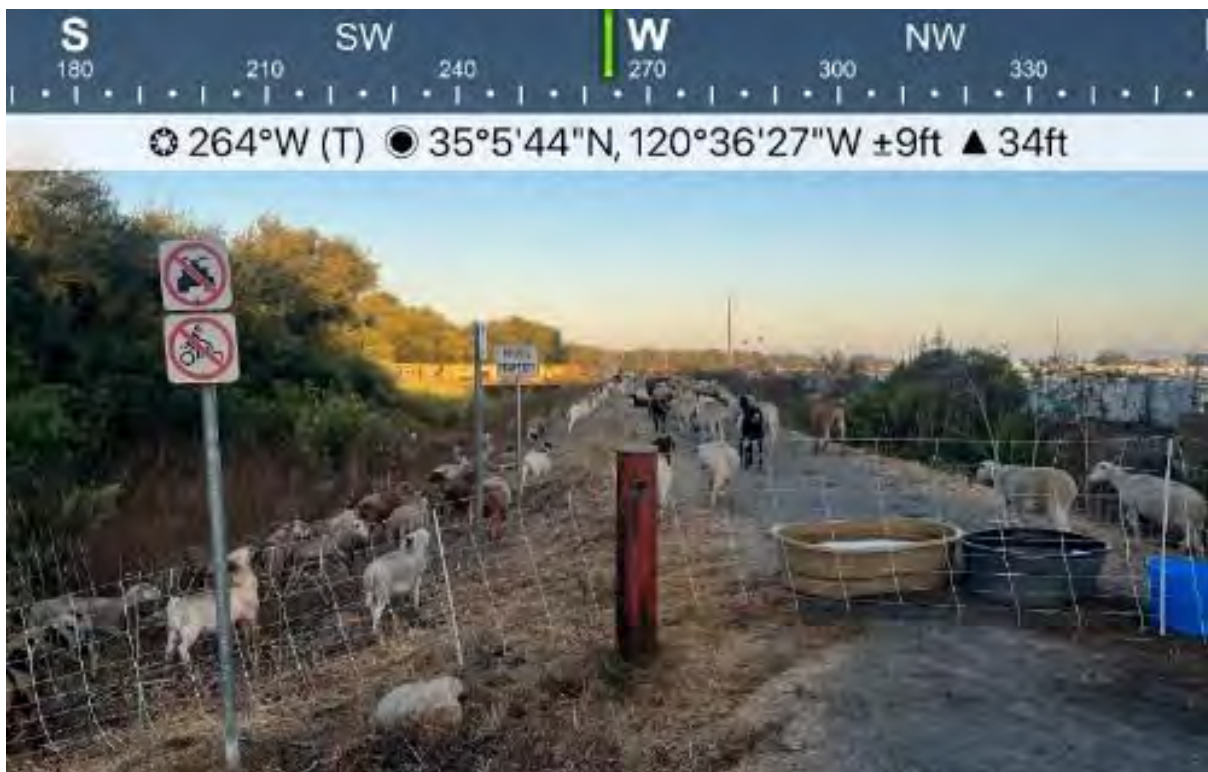
**Photograph 2.** Goats utilized for vegetation removal downstream on 22<sup>nd</sup> Street bridge, facing north. August 20, 2025.

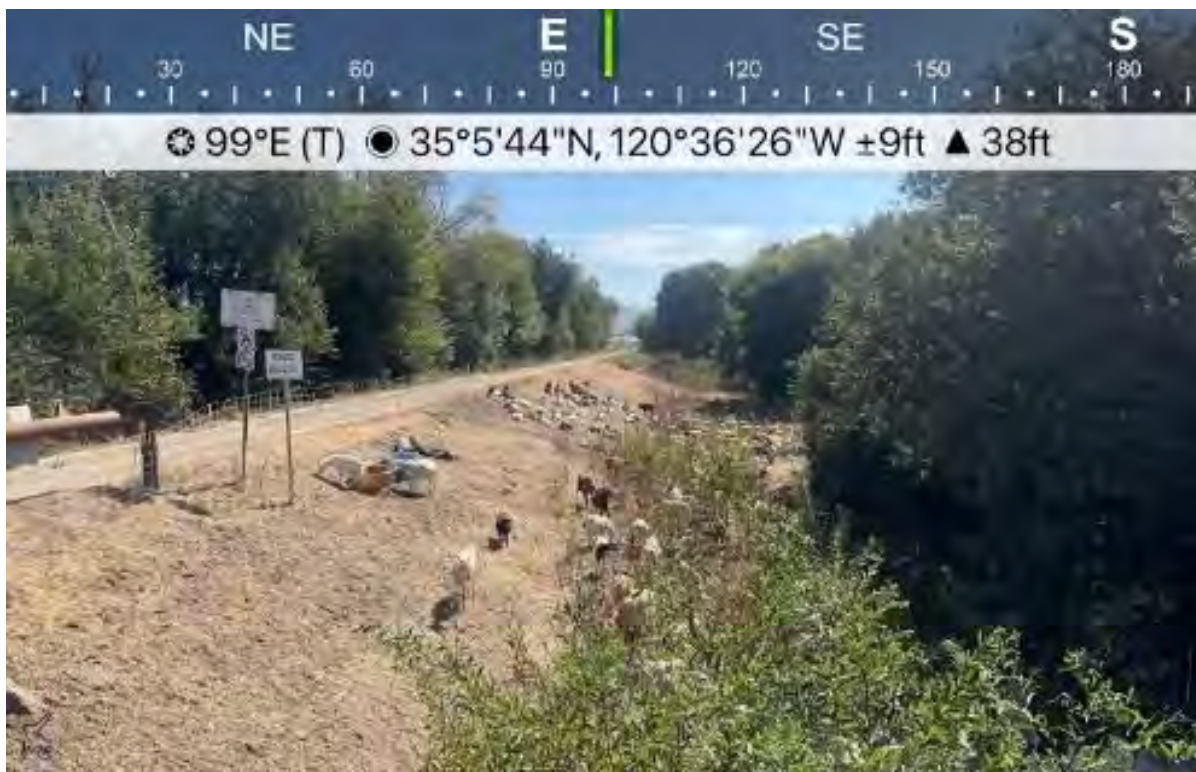
**Photograph 3.** Goats utilized for vegetation removal downstream on 22<sup>nd</sup> Street bridge, facing east. August 20, 2025.

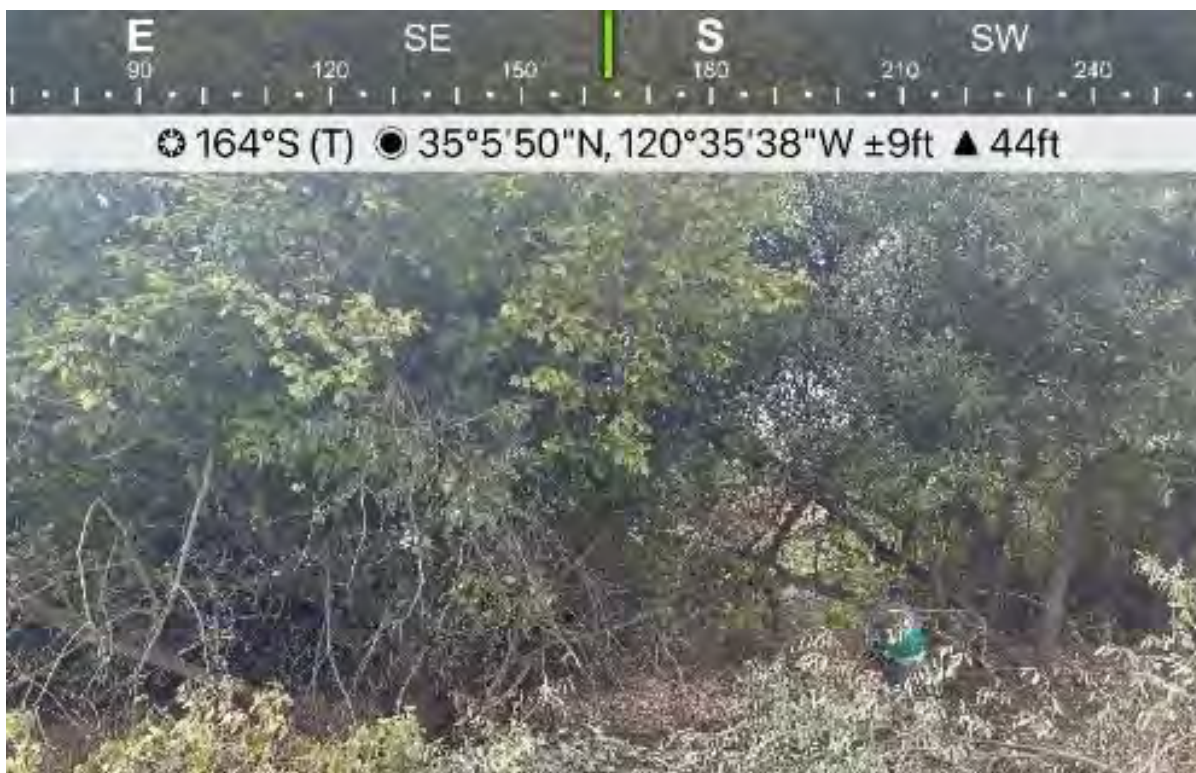
**Photograph 4.** Vegetation management crew trimming woody vegetation within the secondary channel north of Arroyo Grande Creek, facing south. September 16, 2025.

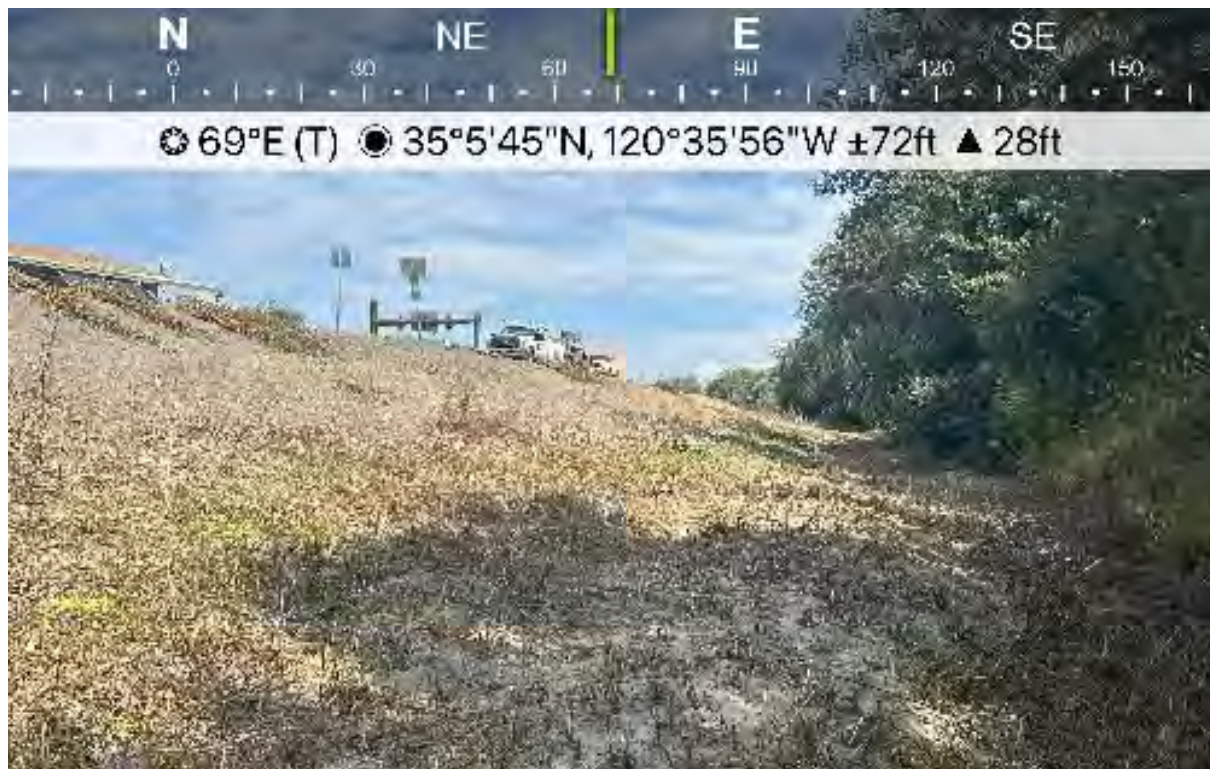
**Photograph 6.** Levee road north of Arroyo Grande Creek following woody vegetation trimming, facing east. September 16, 2025.

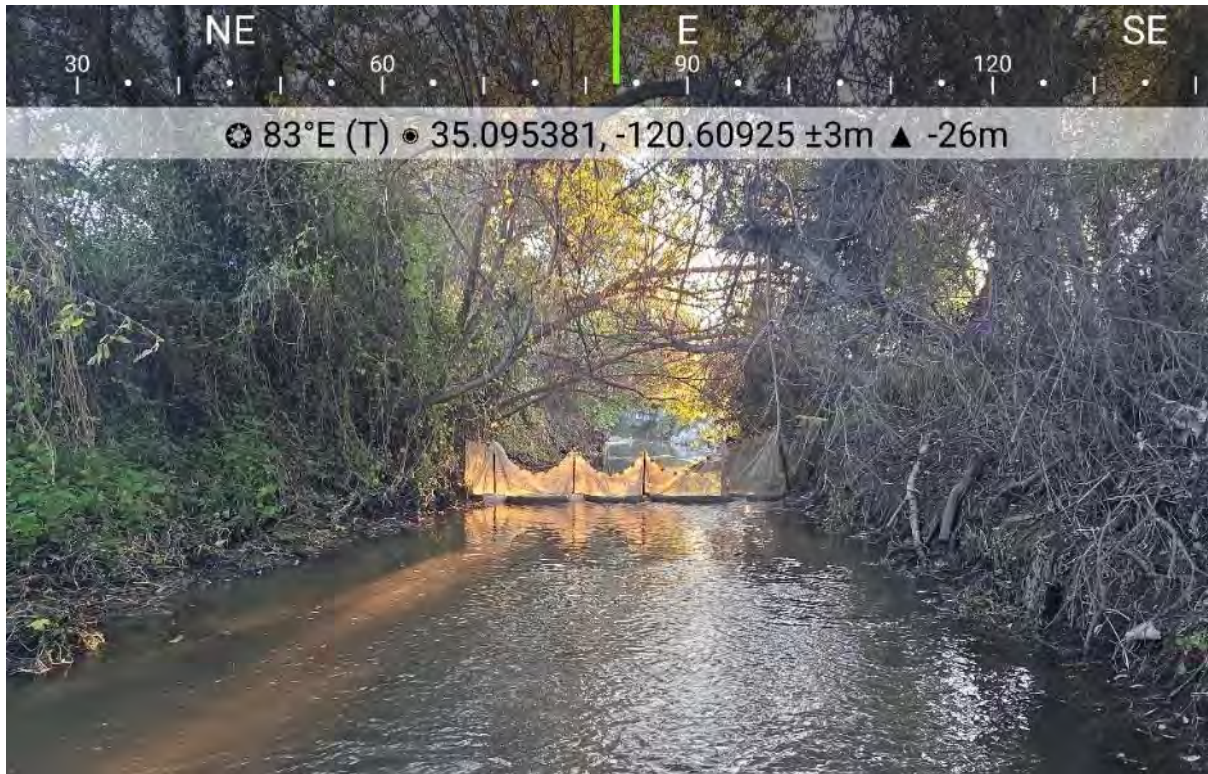
The 2023 Breach Site Levee Repair Project (Breach Site) involved the permanent repair of the location of a 2023 levee breach. The levee damage and resulting breach were caused by severe flooding during a January 2023 atmospheric river precipitation event. An emergency repair of the breach site was completed in 2023, however, deficiencies in the 2023 emergency repair were noted, due to the work occurring during high flows, including the bank's inability to support riparian vegetation—an ecological function and a primary objective of the WMP.

**Photograph 7.** Looking east at the upstream block at the Breach Site. October 16, 2025.

The District submitted the 2025 Updated Work Plan on August 1, 2025, detailing the planned repair including stream diversion, addition of rock slope protection (RSP), and backfill with soil and riparian plantings. The 2025 Updated Work Plan included construction drawings, a *Diversion Dewatering Plan*, and *Fish Removal and Rescue Plan for Steelhead Trout and Tidewater Goby*.

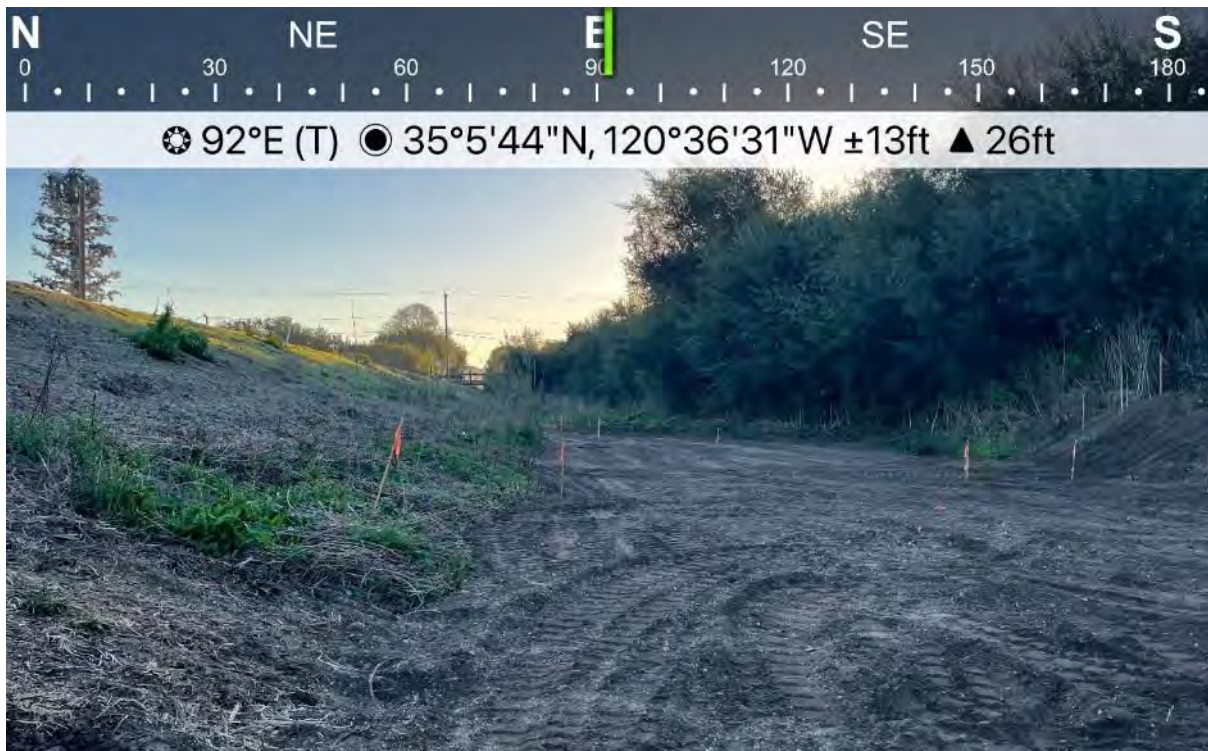
Annual sediment management activities took place in late October, concurrent with the Breach Site repairs. Routine sediment management included sediment removal at SMZ 7 and sediment/vegetation removal 20 feet upstream and downstream of the UPRR Bridge. Sediment removal at SMZ 7 excavated approximately 300 cubic yards of sediment within approximately 190 linear feet of the secondary channel, contiguous with the UPRR Bridge.

**Photograph 14.** Looking upstream (east) within the secondary channel sediment removal area of SMZ 7. October 23, 2025.

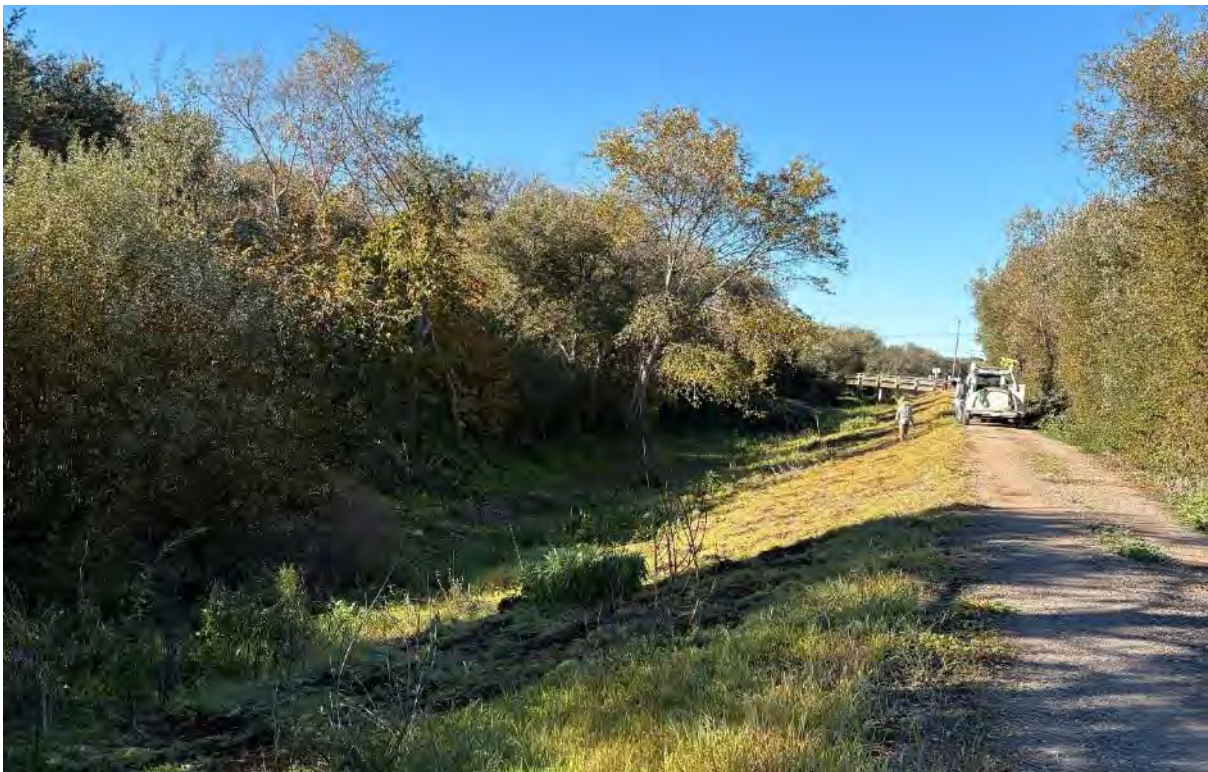
**Photograph 18.** Planting container plants at SMZ 8. December 8, 2025.

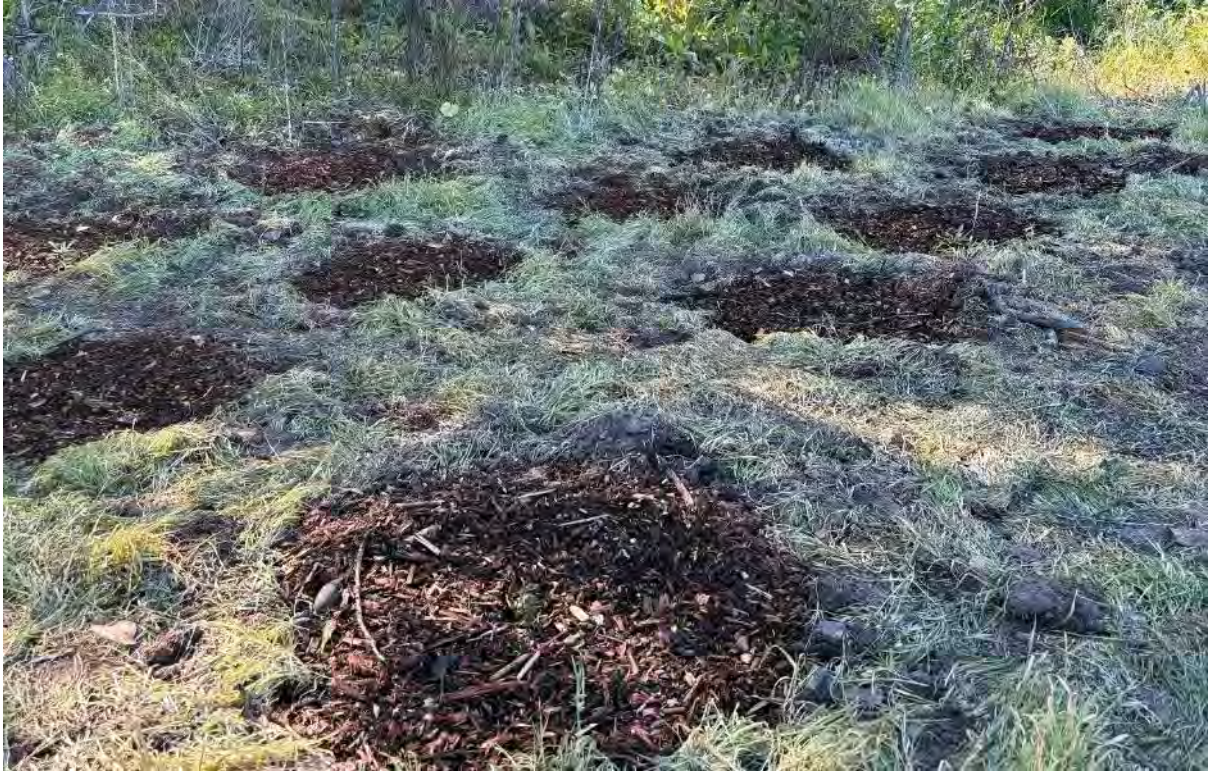
**Photograph 19.** Newly planted native perennials with mulch topdressing; SMZ 8. December 8, 2025.

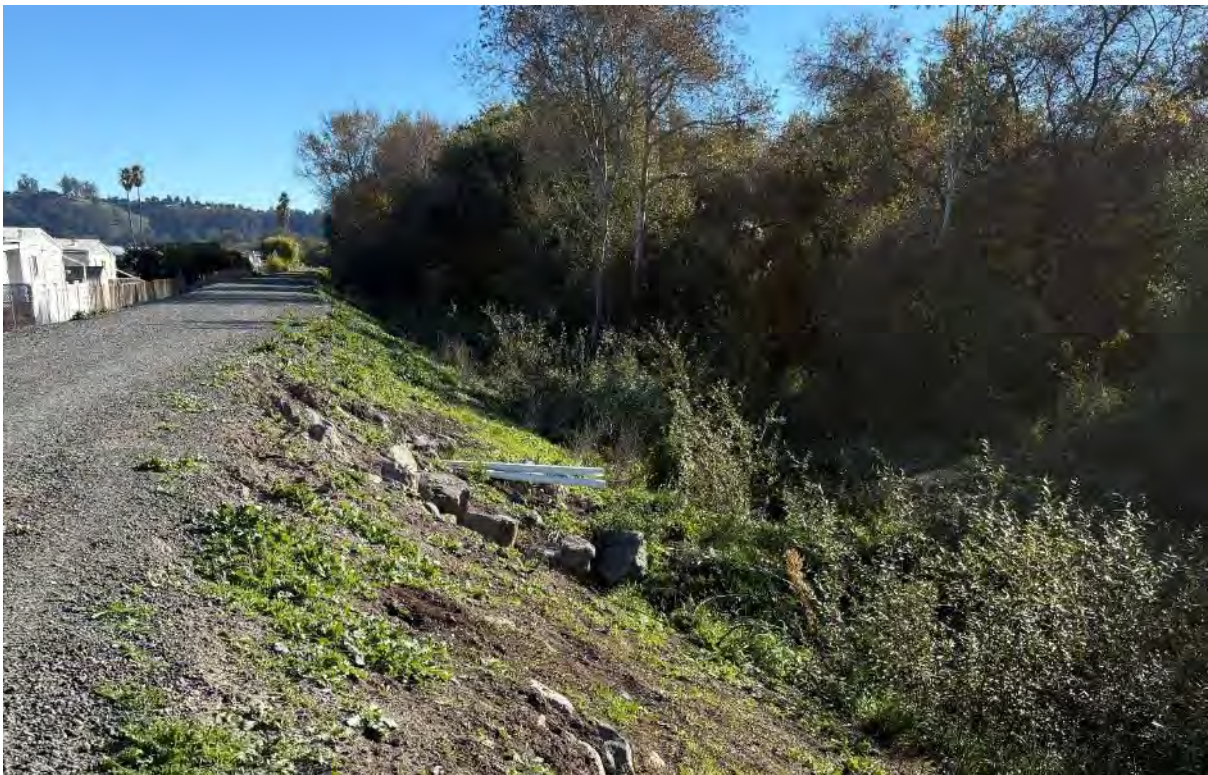
**Photograph 20.** Site preparation for new container plantings at SMZ 10. December 8, 2025.

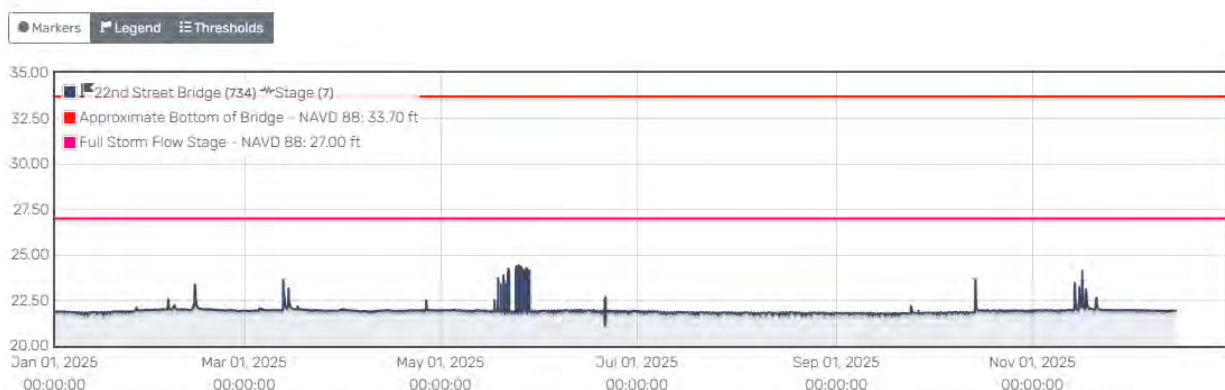
**Figure 1. 22nd Street Bridge Gage Stage Data 2025**

Conditions remained relatively unchanged since the fall 2024 inspection, which followed sediment and debris removal activities completed throughout most of the project reach. Refer to the 2024 report for locations where maintenance occurred. Storm flows during 2025 were similar to those in 2024, if not lower. The creek did not experience any high-flow events exceeding full storm flow stage at the 22nd Street Bridge gage (County of San Luis Obispo Public Works Department, 2025). Figure 1 includes a graph showing flow stage at 22nd Street Bridge during 2025.

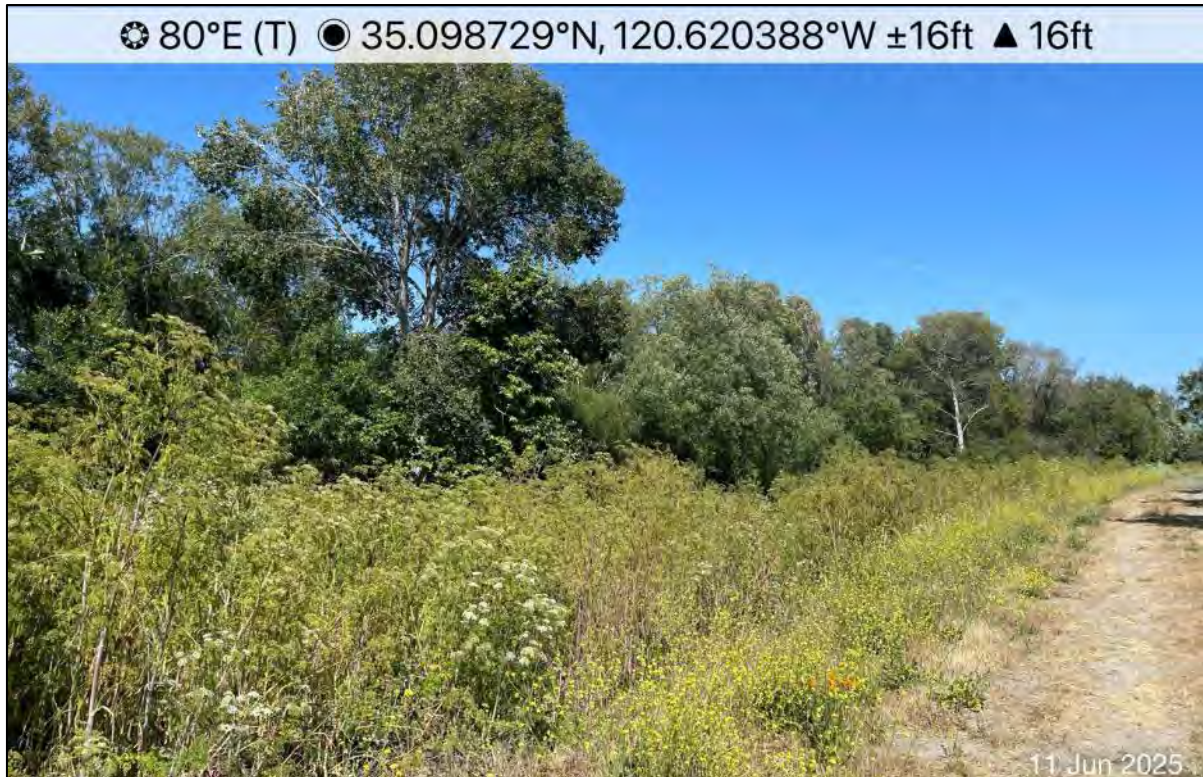
**Photograph 1.** View of SMZ 1, facing east. June 11, 2025.

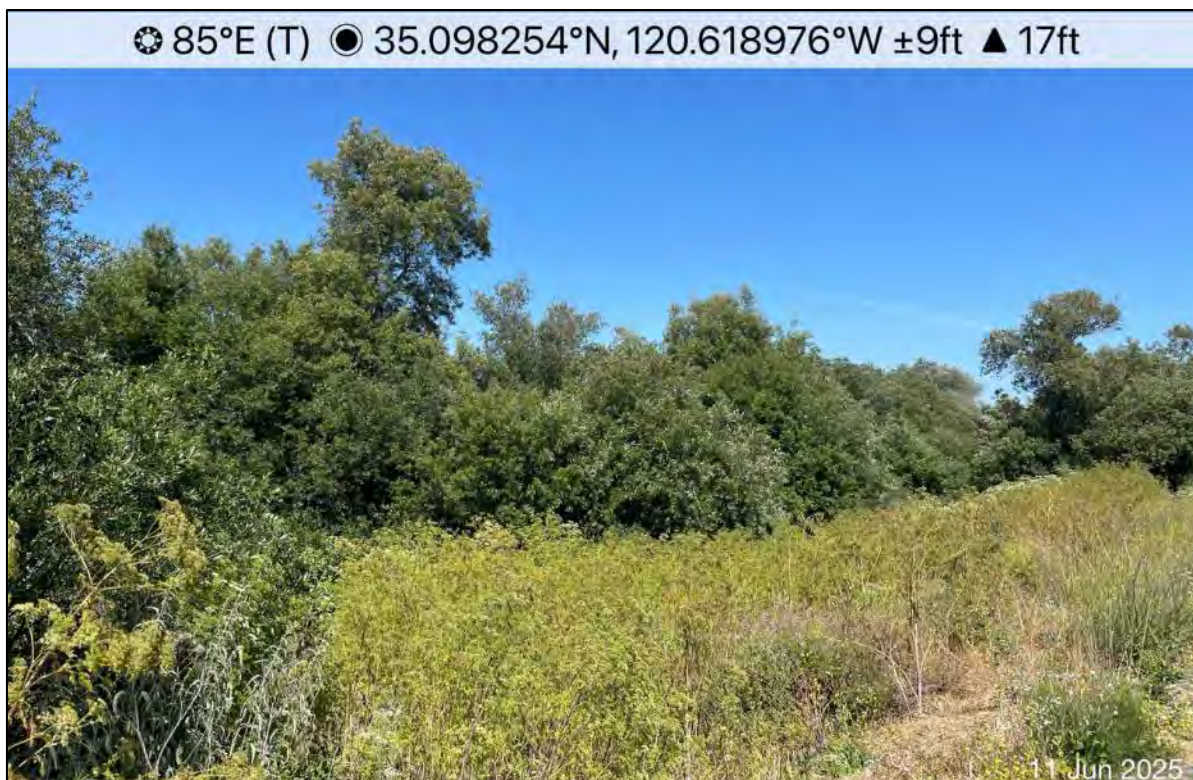
**Photograph 3.** View of SMZ 2, facing east. June 11, 2025.

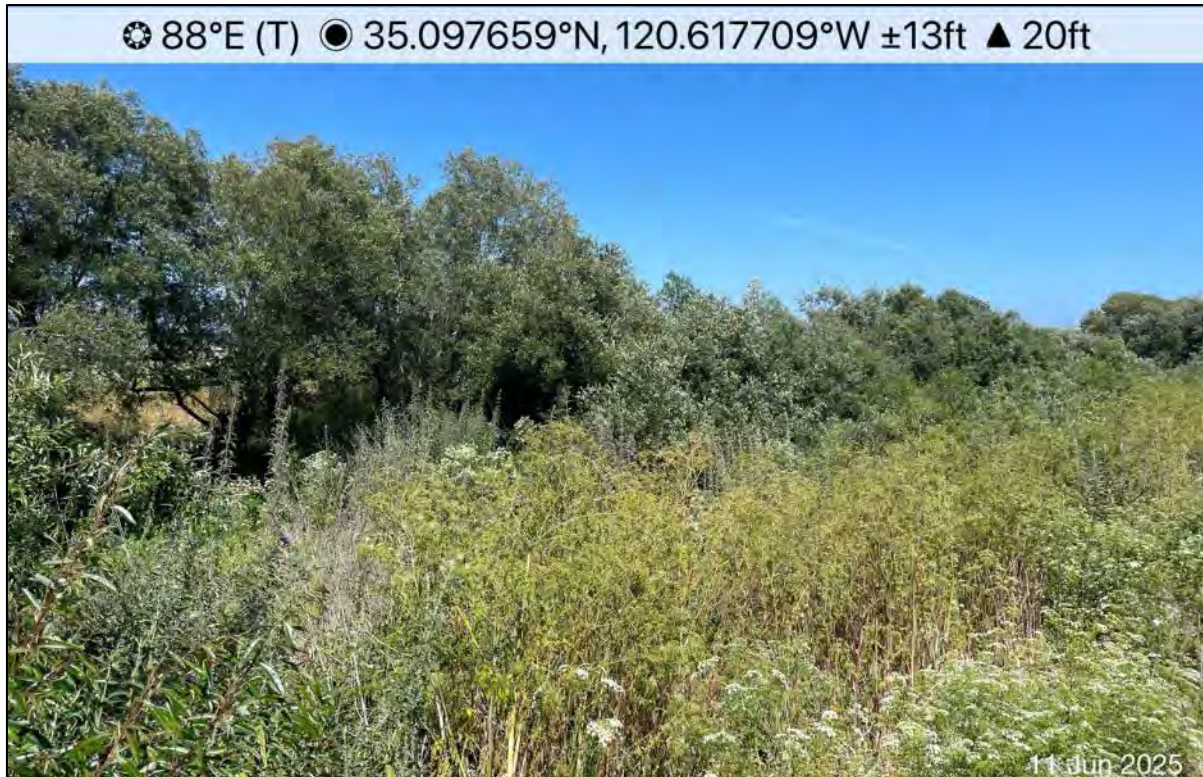
**Photograph 5.** View of SMZ 3, facing east. June 11, 2025.

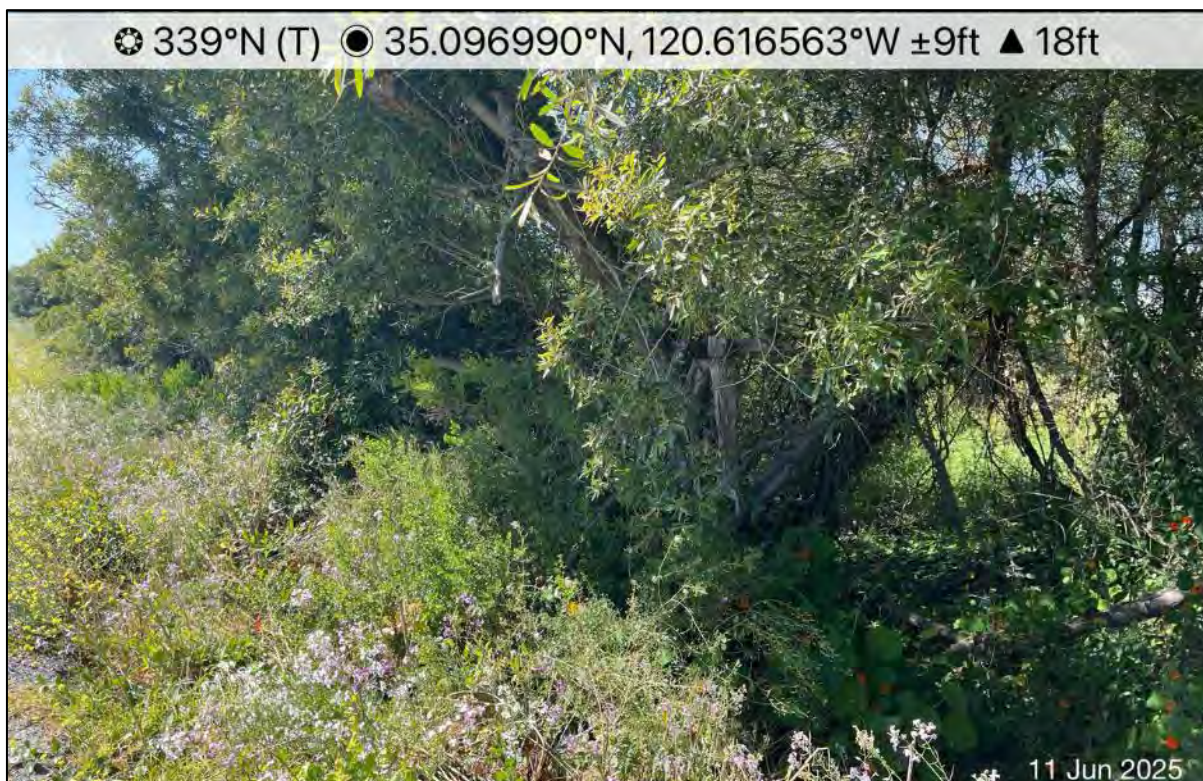
**Photograph 6.** View of SMZ 3, facing north. June 11, 2025.

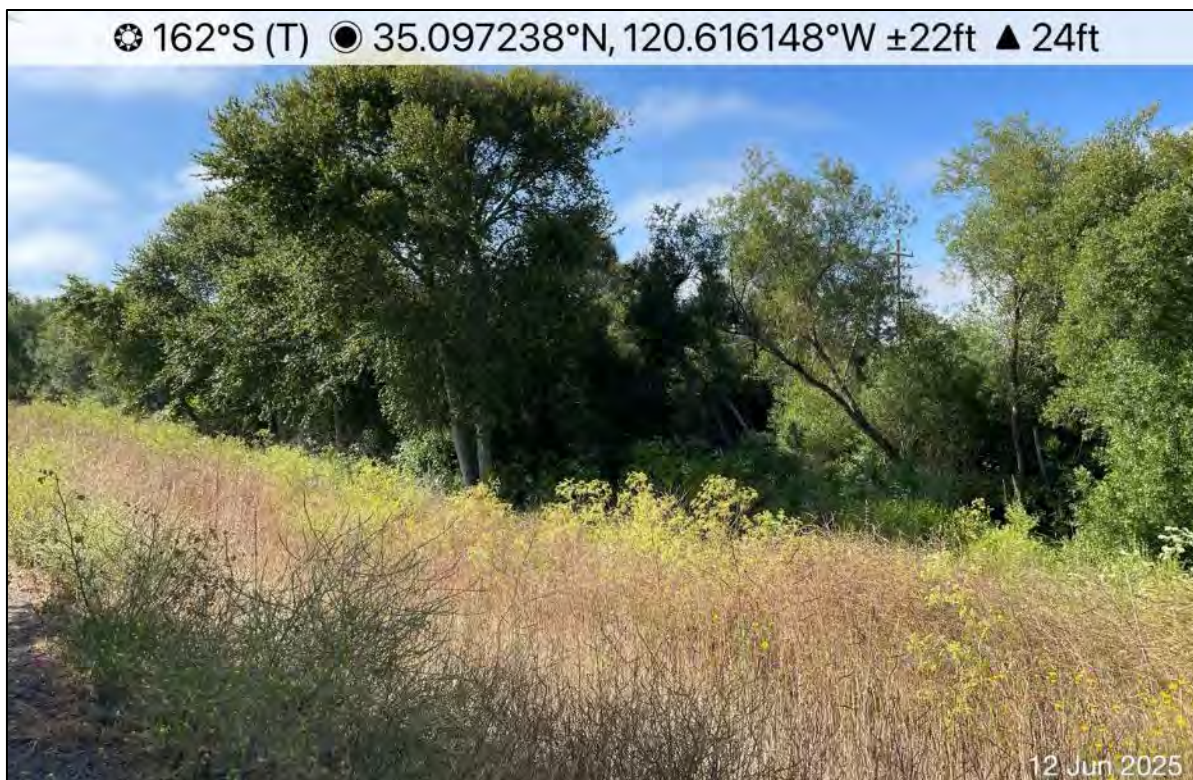
**Photograph 7.** View of SMZ 4, facing south. June 12, 2025.

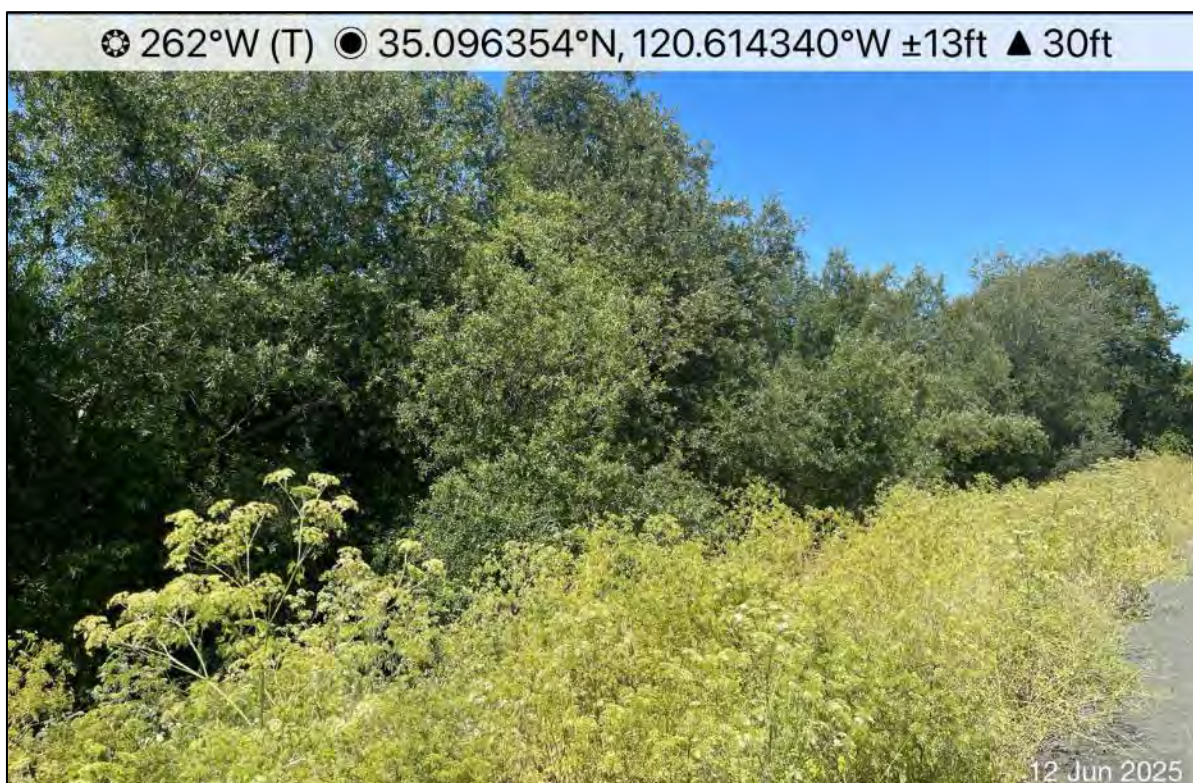
**Photograph 8.** View of SMZ 4, facing west. June 12, 2025.

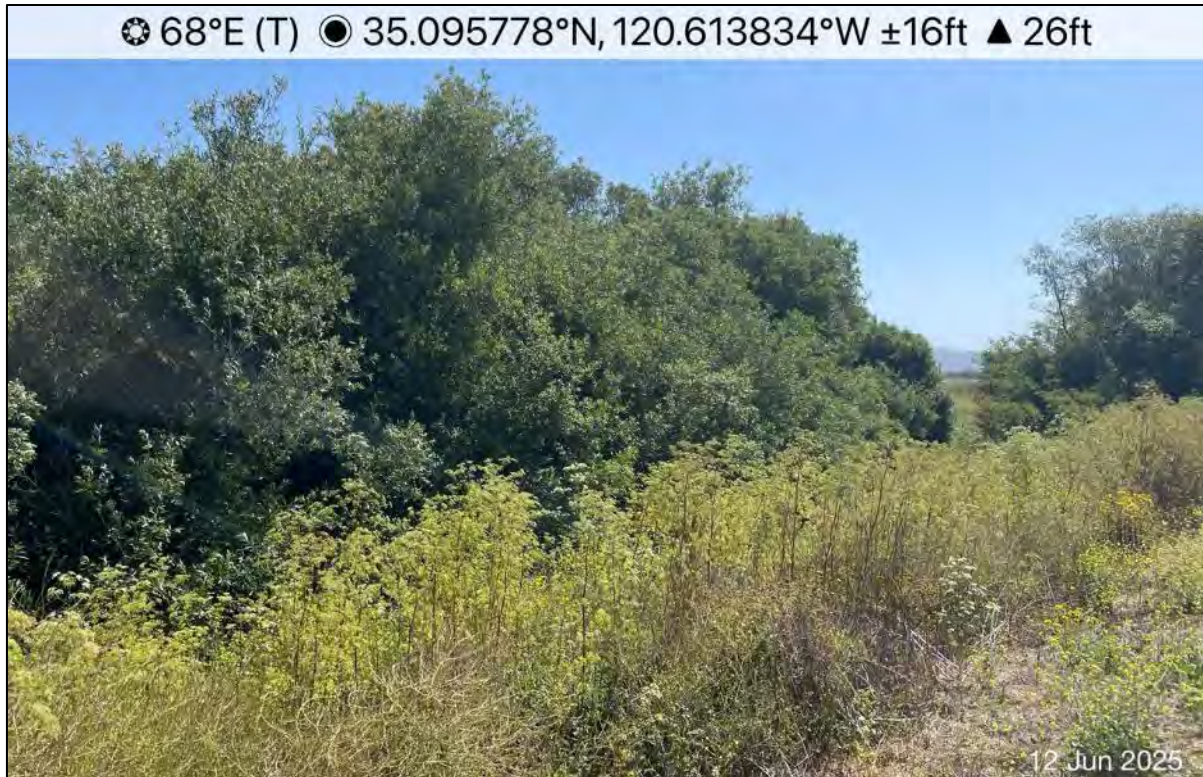
**Photograph 9.** View of SMZ 5, facing east. June 12, 2025.

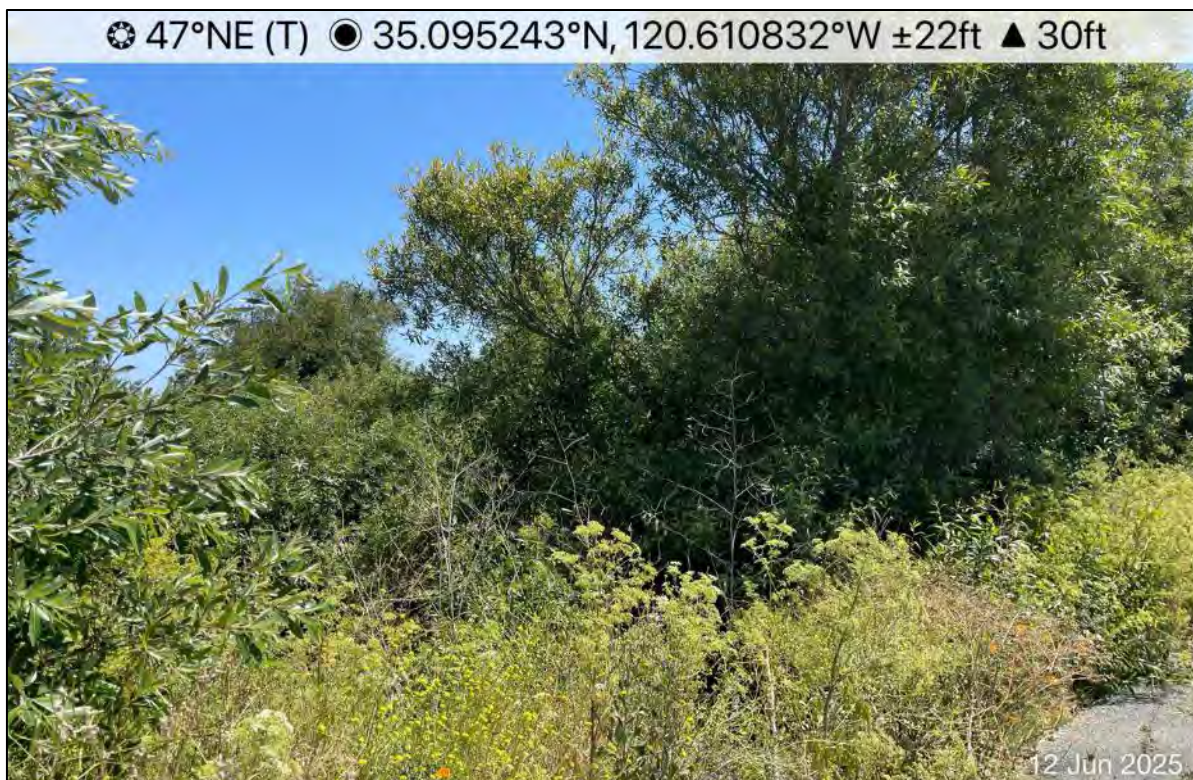
**Photograph 11.** View of SMZ 6, facing northeast. June 12, 2025.

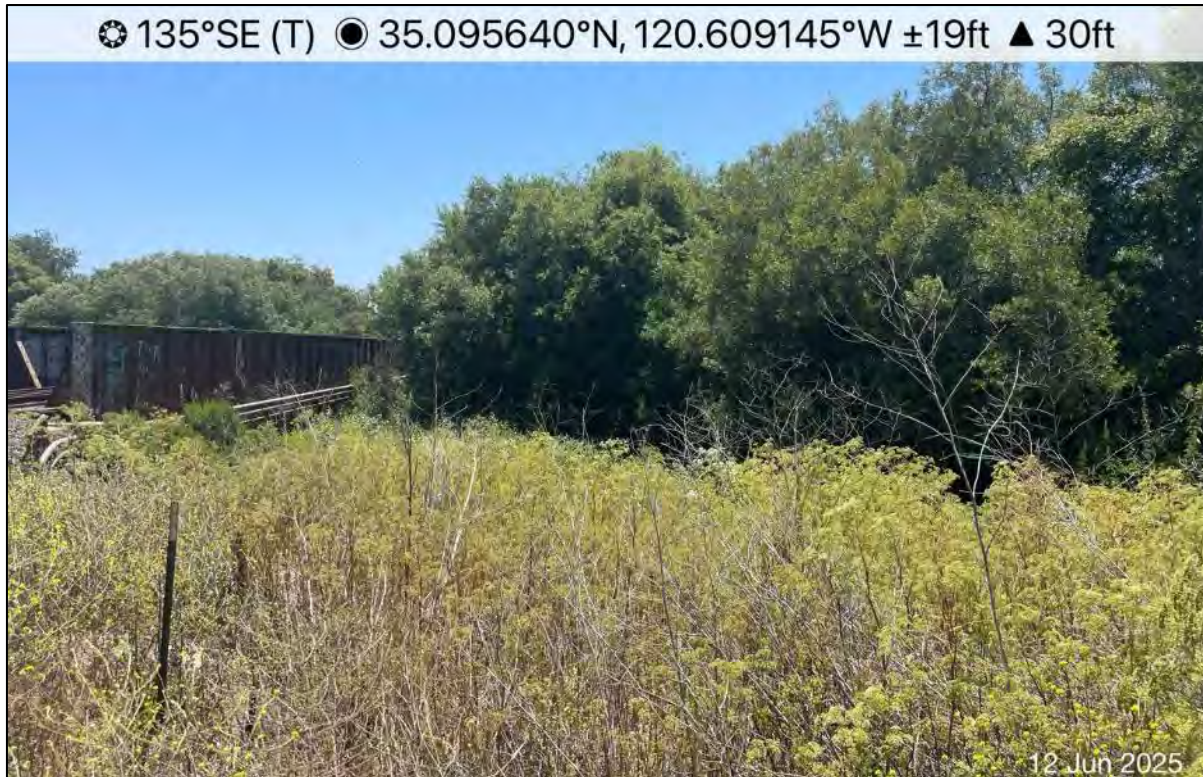
**Photograph 13.** View of SMZ 7, facing southeast. June 12, 2025.

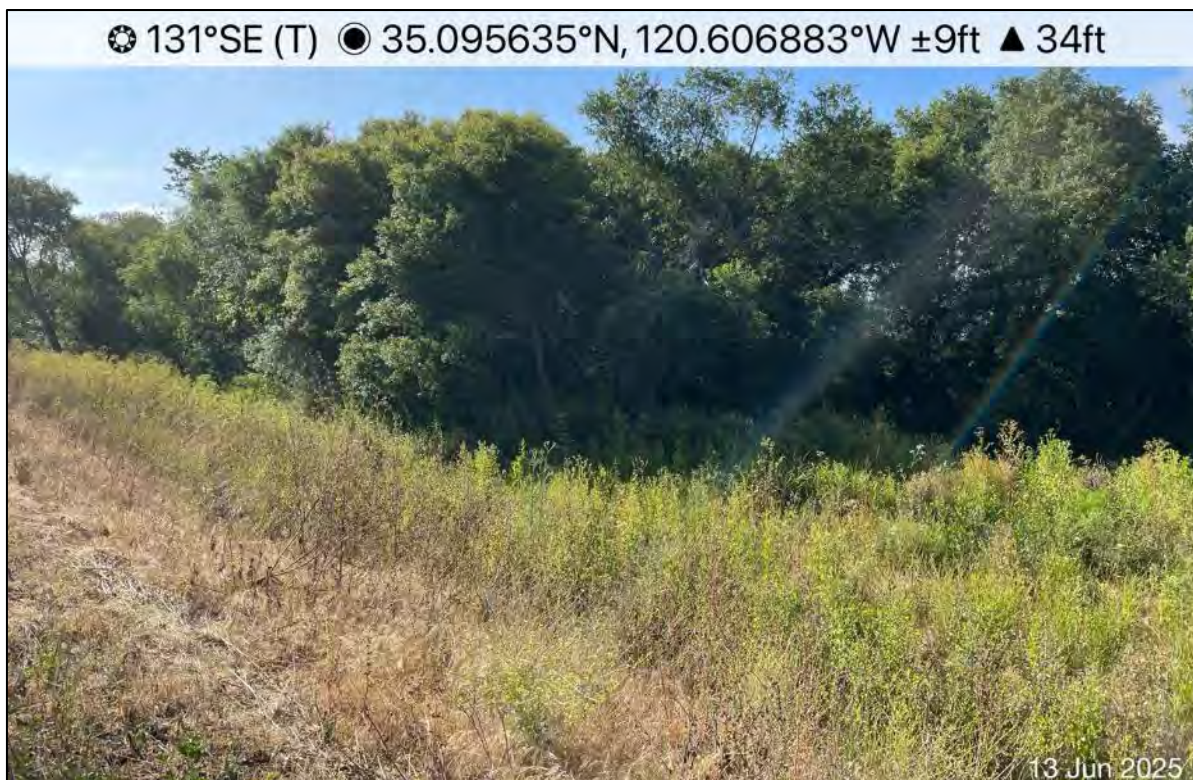
**Photograph 15.** View of SMZ 8, facing southeast. June 13, 2025.

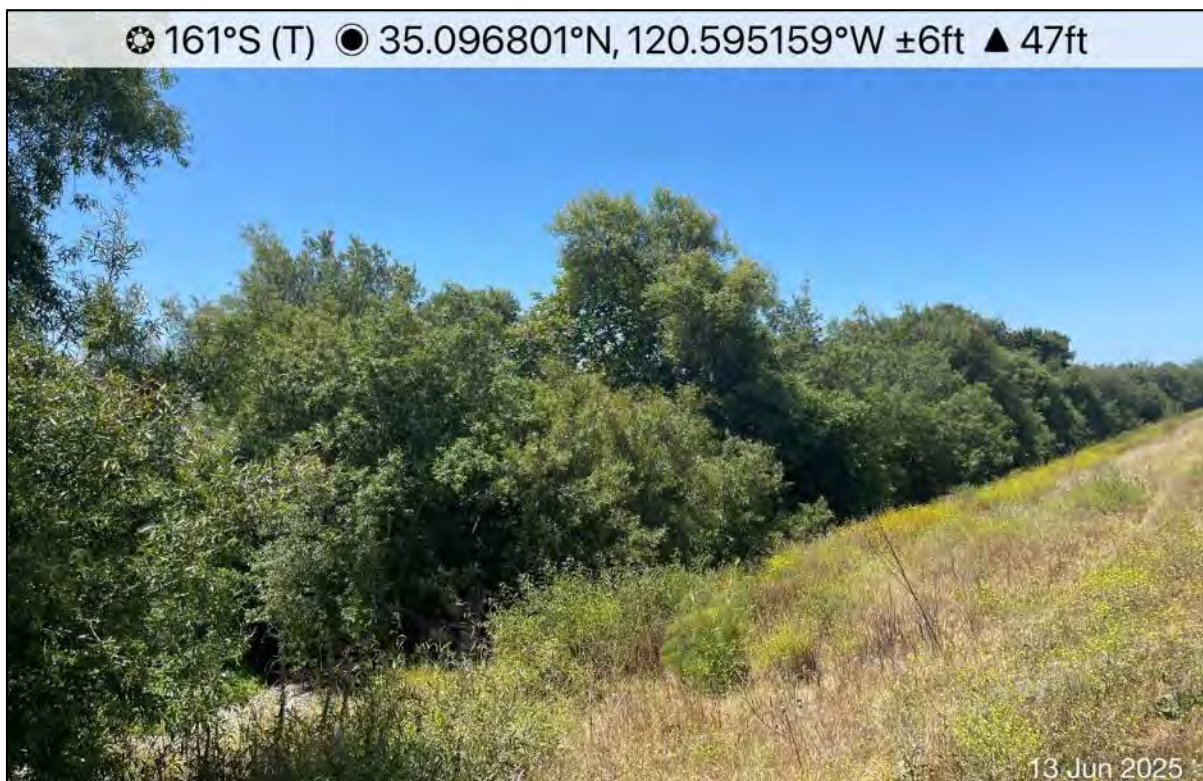
**Photograph 25.** View from the middle of SMZ 13, facing southeast. June 13, 2025.

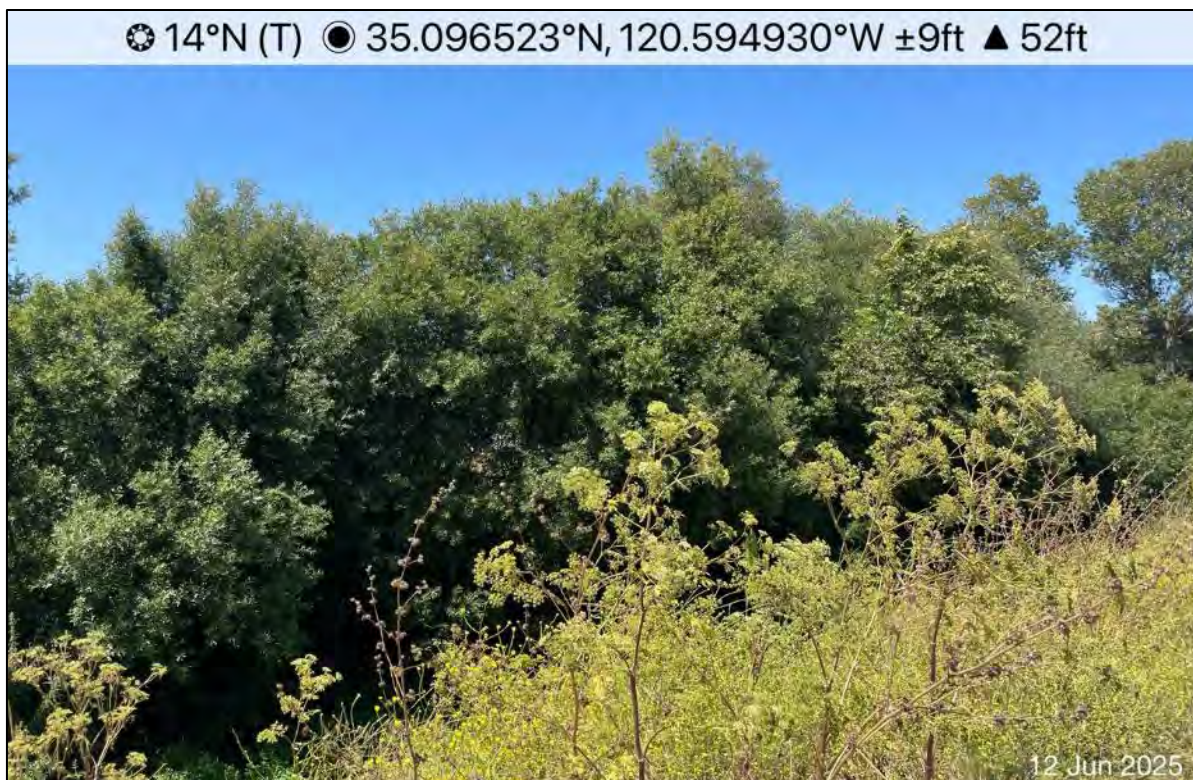
**Photograph 26.** View from edge of SMZ 13, facing south. June 13, 2025.

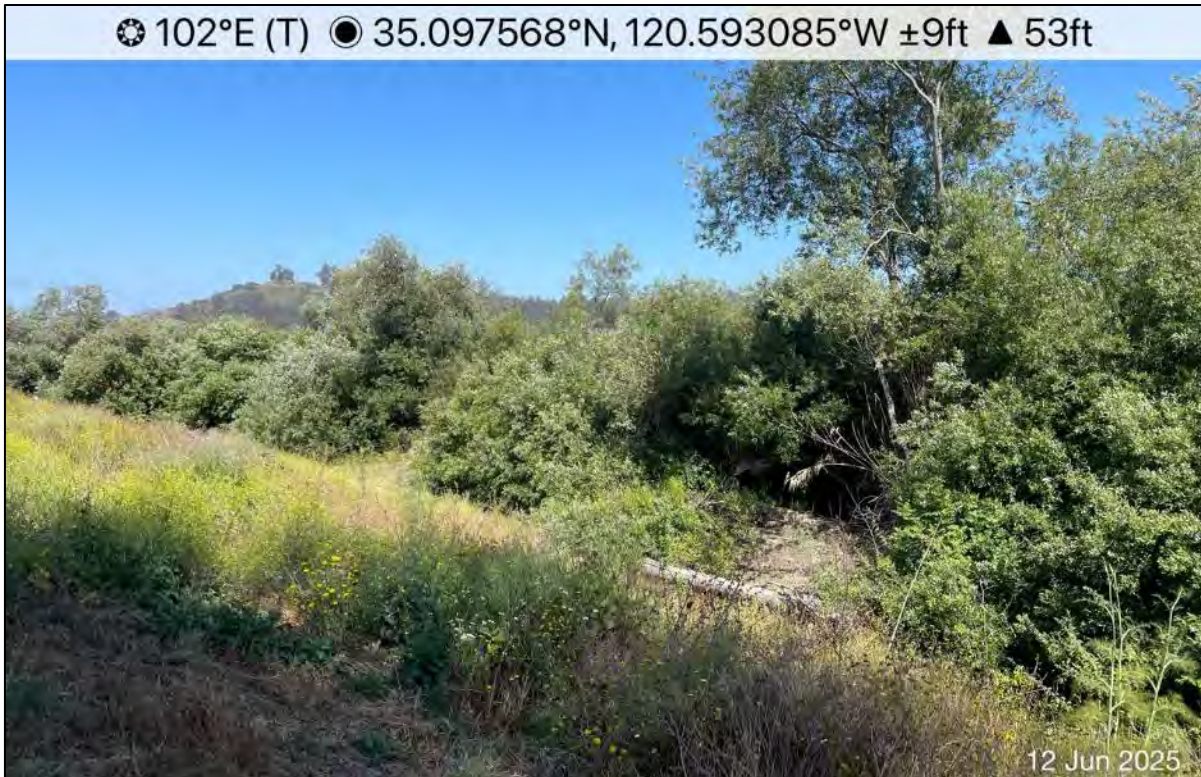
**Photograph 28.** View of SMZ 14, facing northwest. June 12, 2025.
