**Project Name  
(as found on  
Certification):** Arroyo Grande Creek Channel Waterway Management  
Program

# Arroyo Grande Creek Channel Waterway Management Program

Regional Water Quality Control Board,  
Certification No. 34012WQ01 Annual Report

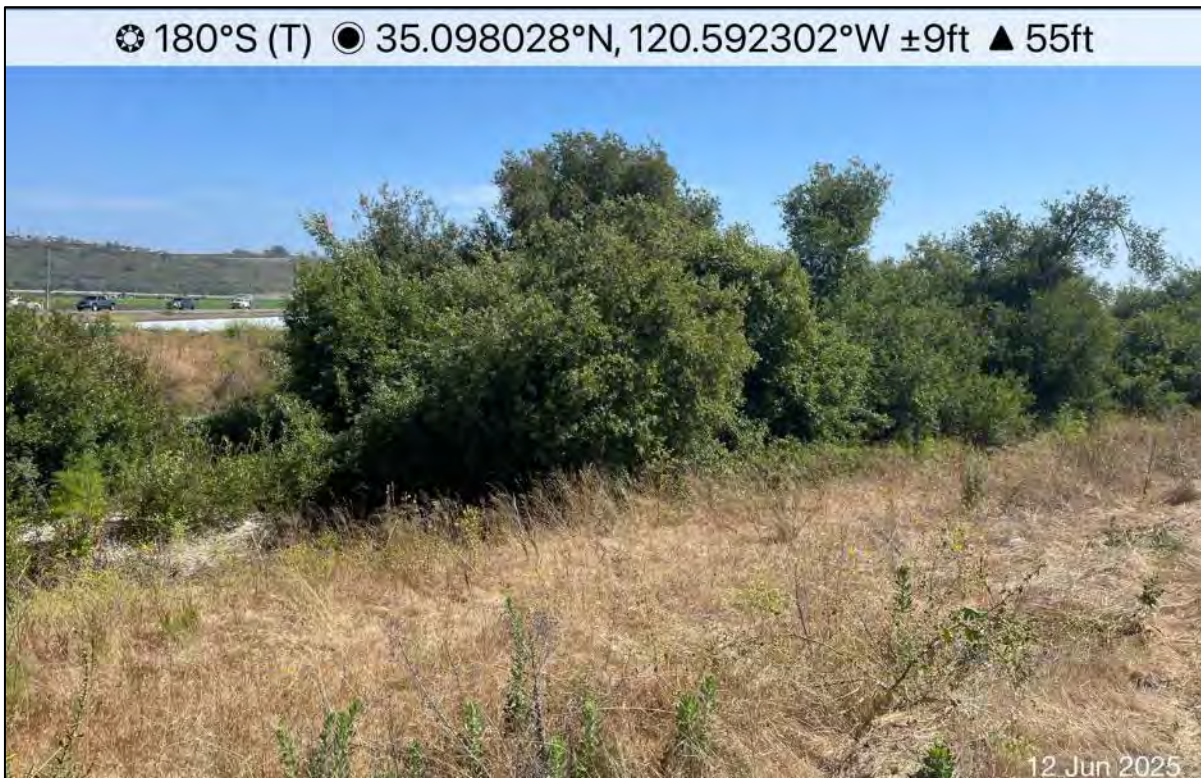
**Photograph 29.** View of SMZ 15, facing east. June 12, 2025.

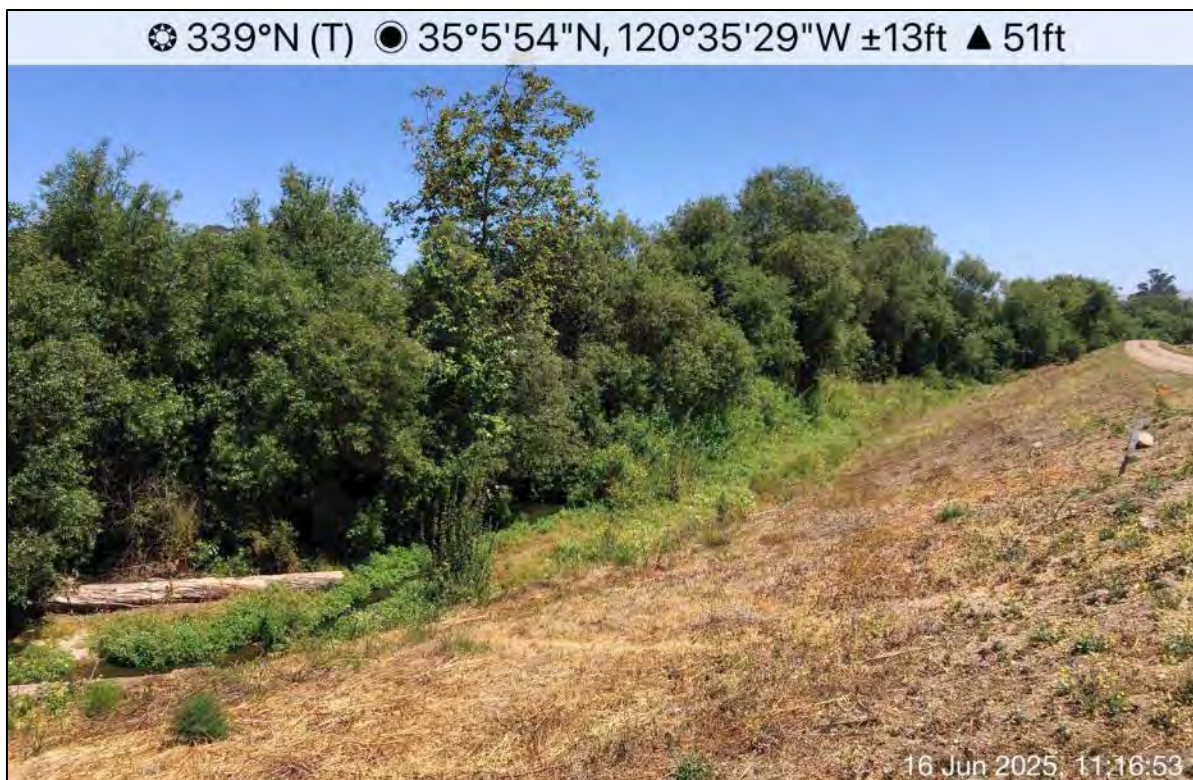
**Photograph 30.** View of SMZ 15, facing south. June 12, 2025.

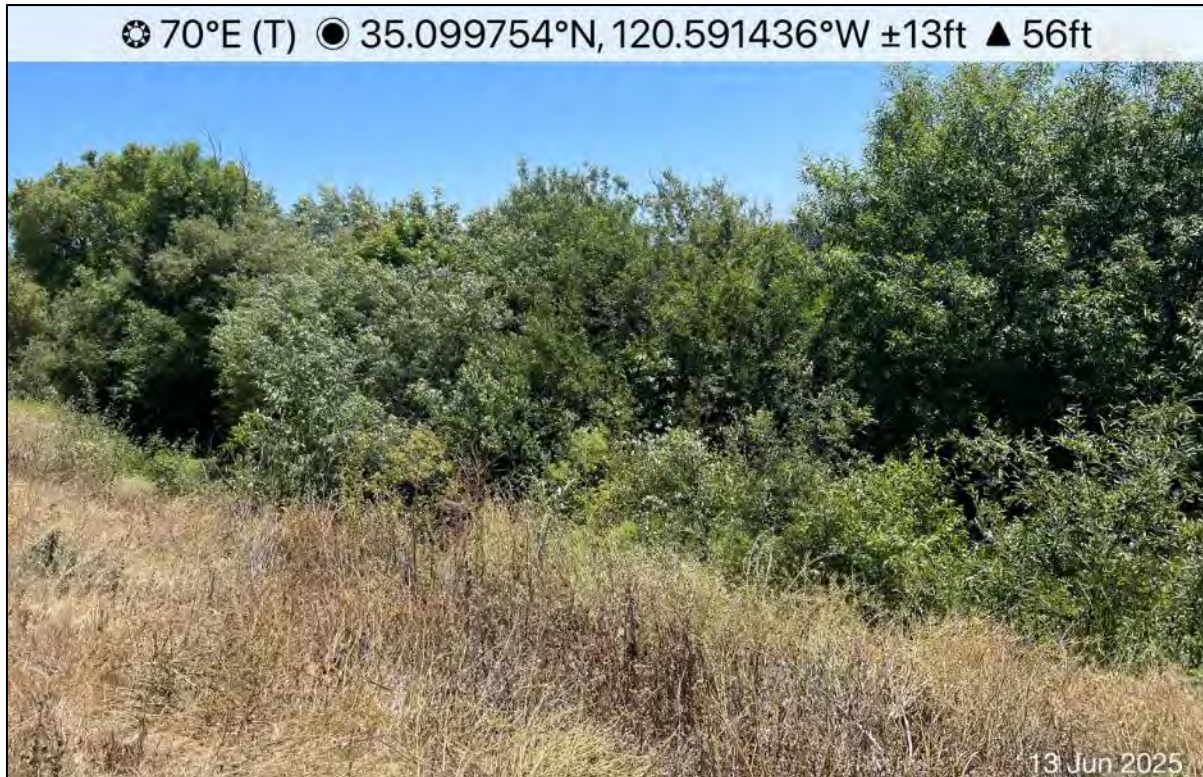
**Photograph 32.** View of SMZ 16, facing southwest. June 16, 2025.

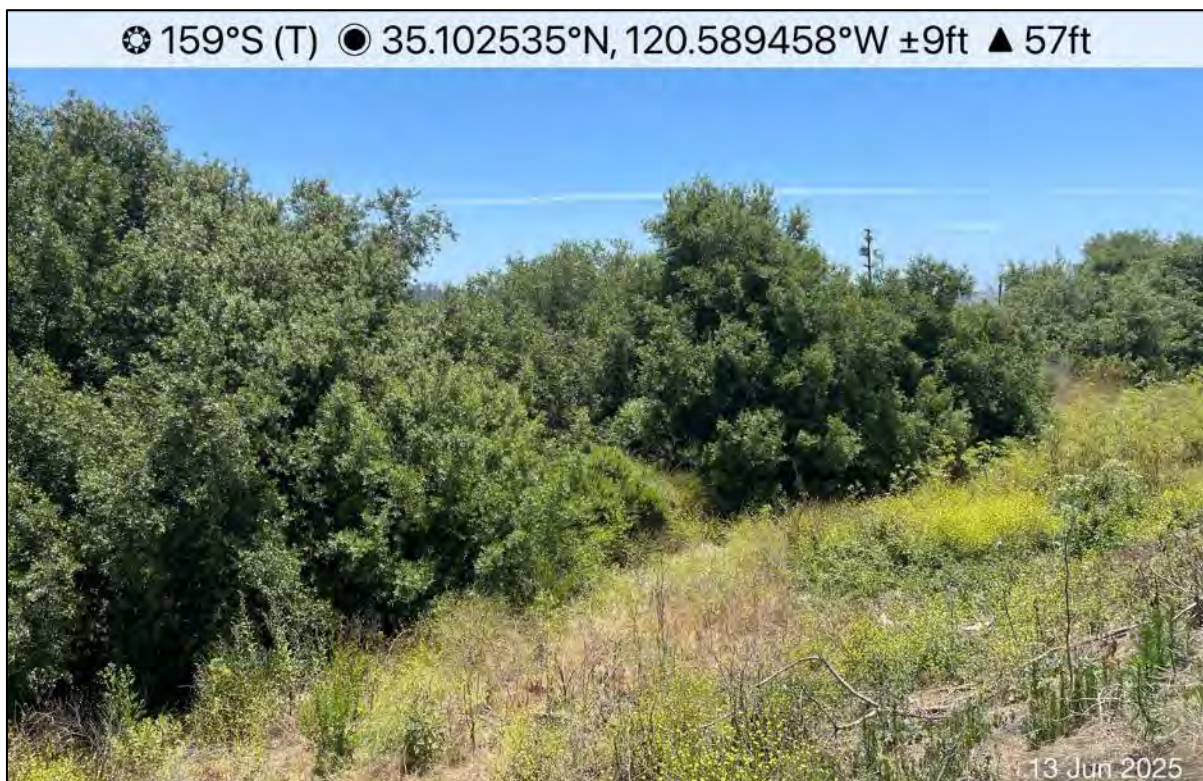
**Photograph 33.** View of SMZ 17, facing east. June 13, 2025.

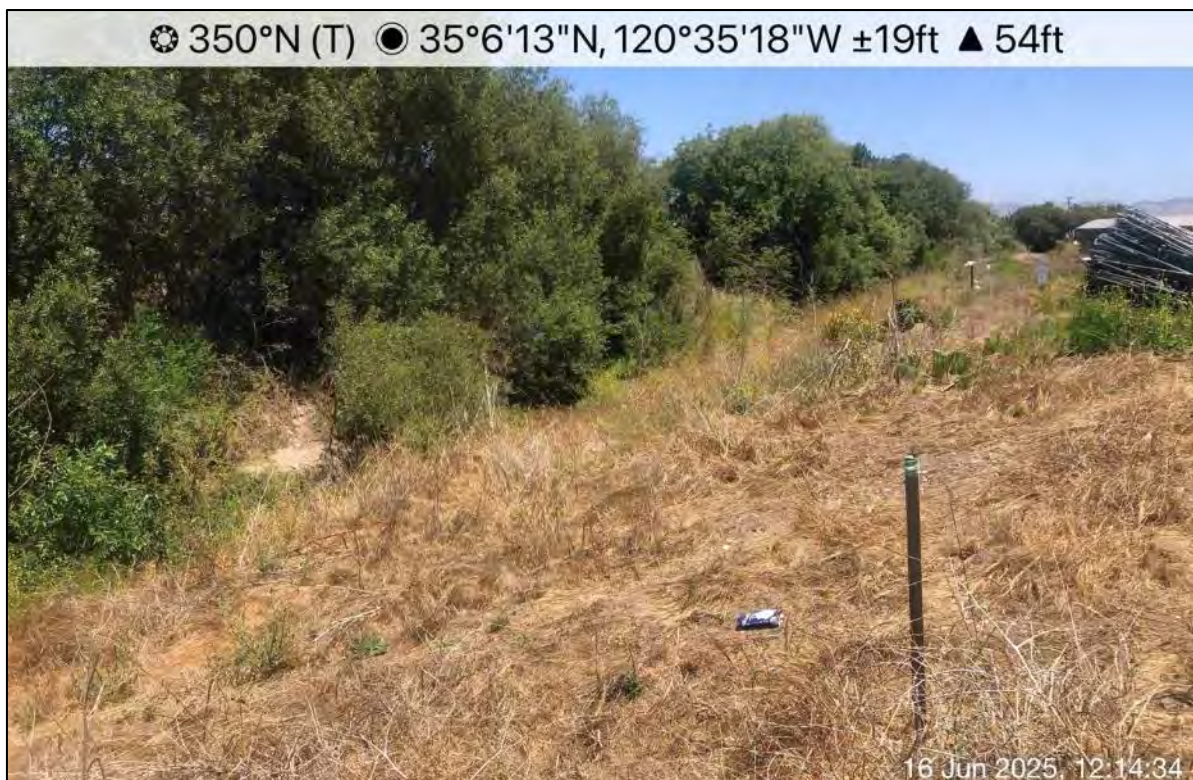
**Photograph 34.** View of SMZ 17, facing south. June 13, 2025.

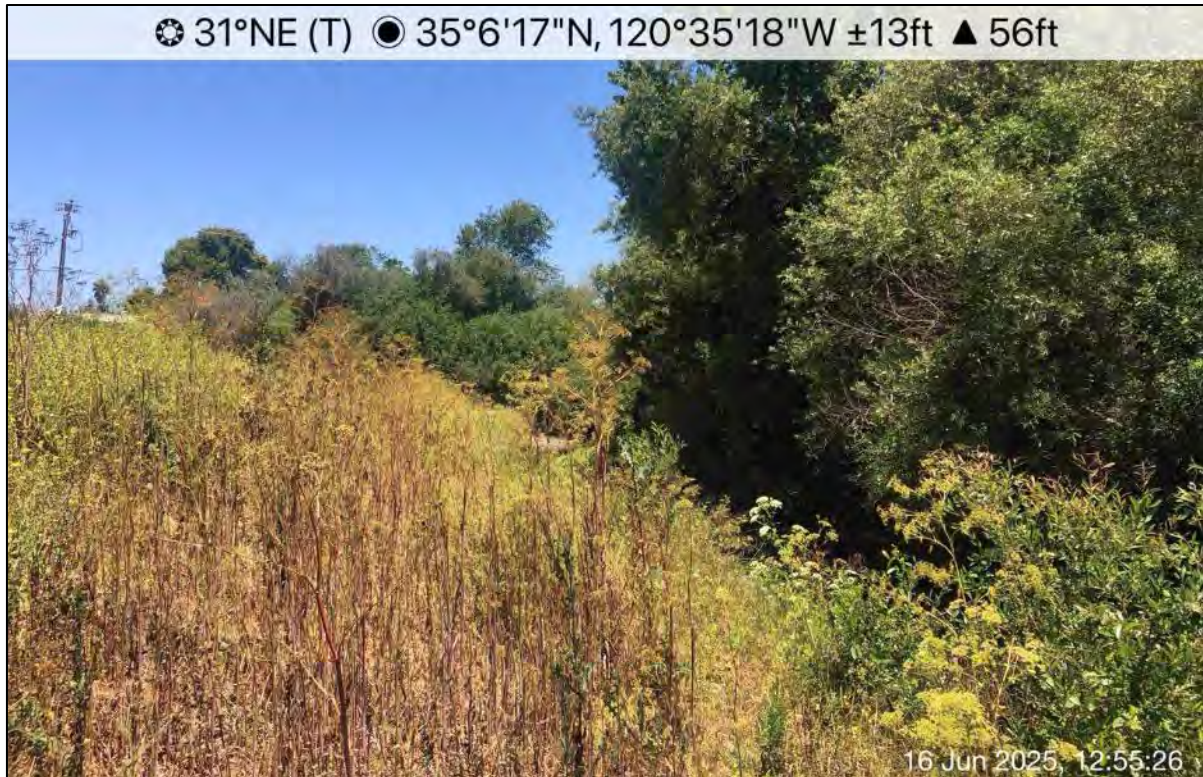
**Photograph 36.** View of SMZ 18, facing southwest. June 16, 2025.

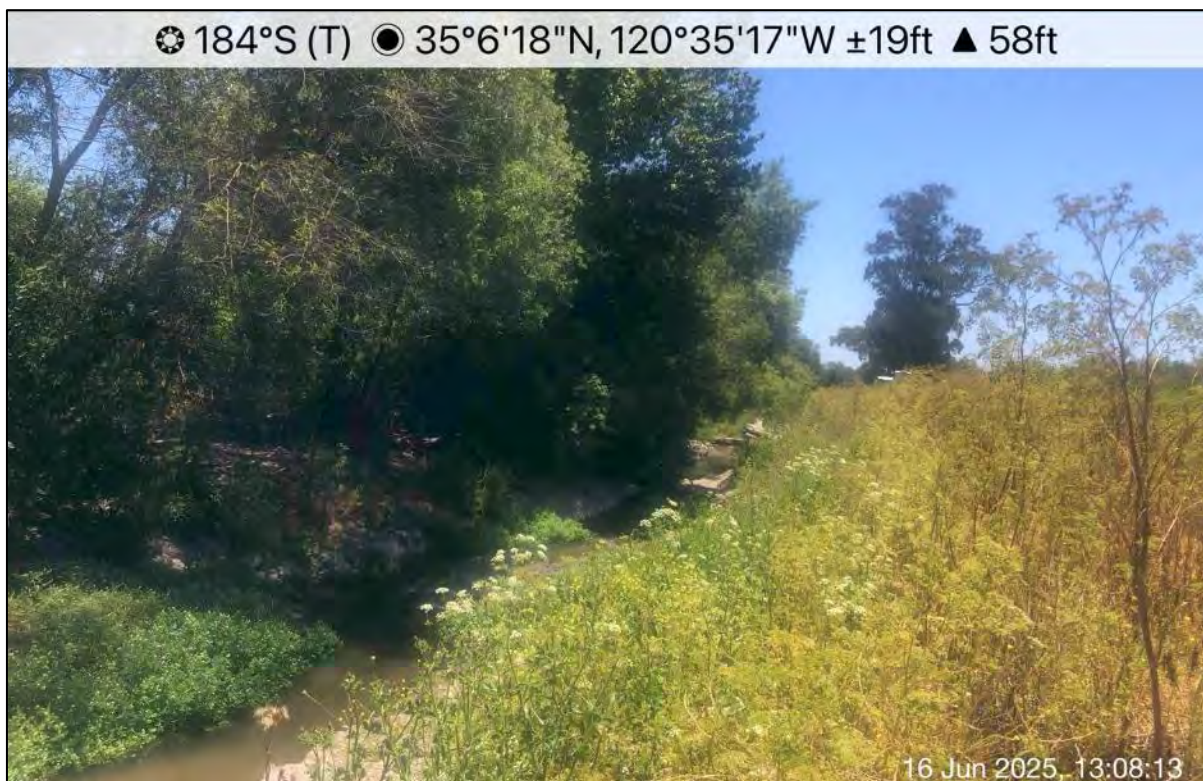
**Photograph 37.** View of SMZ 19, facing northeast. June 16, 2025.

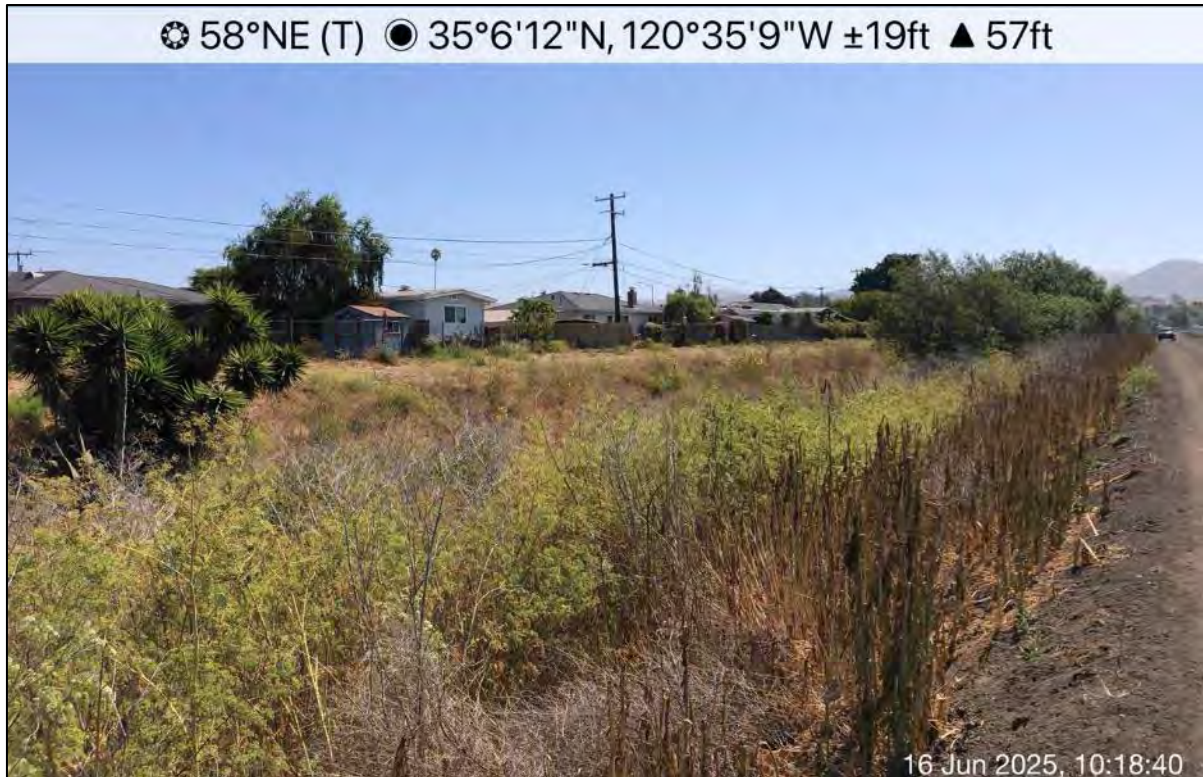
**Photograph 38.** View of SMZ 19, facing south. June 16, 2025.

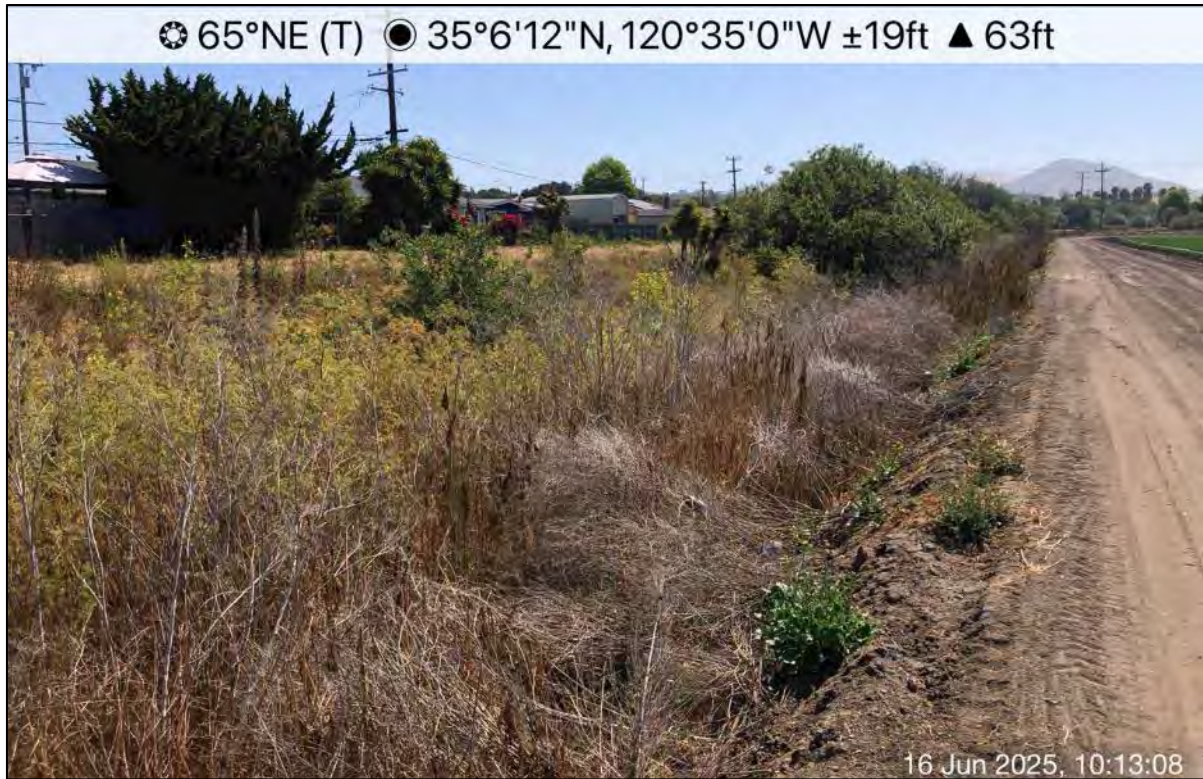
**Photograph 40.** View of SMZ 20, facing northwest. June 16, 2025.

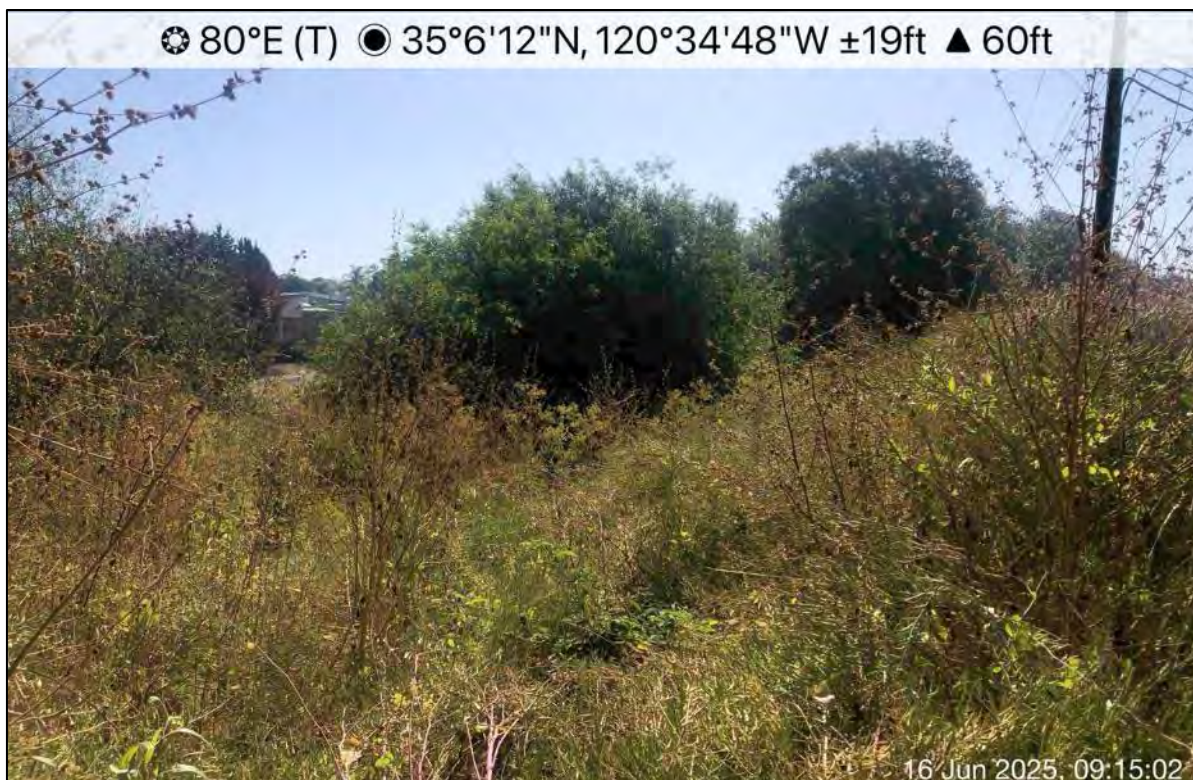
**Photograph 42.** View of SMZ 21, facing southwest. June 16, 2025.

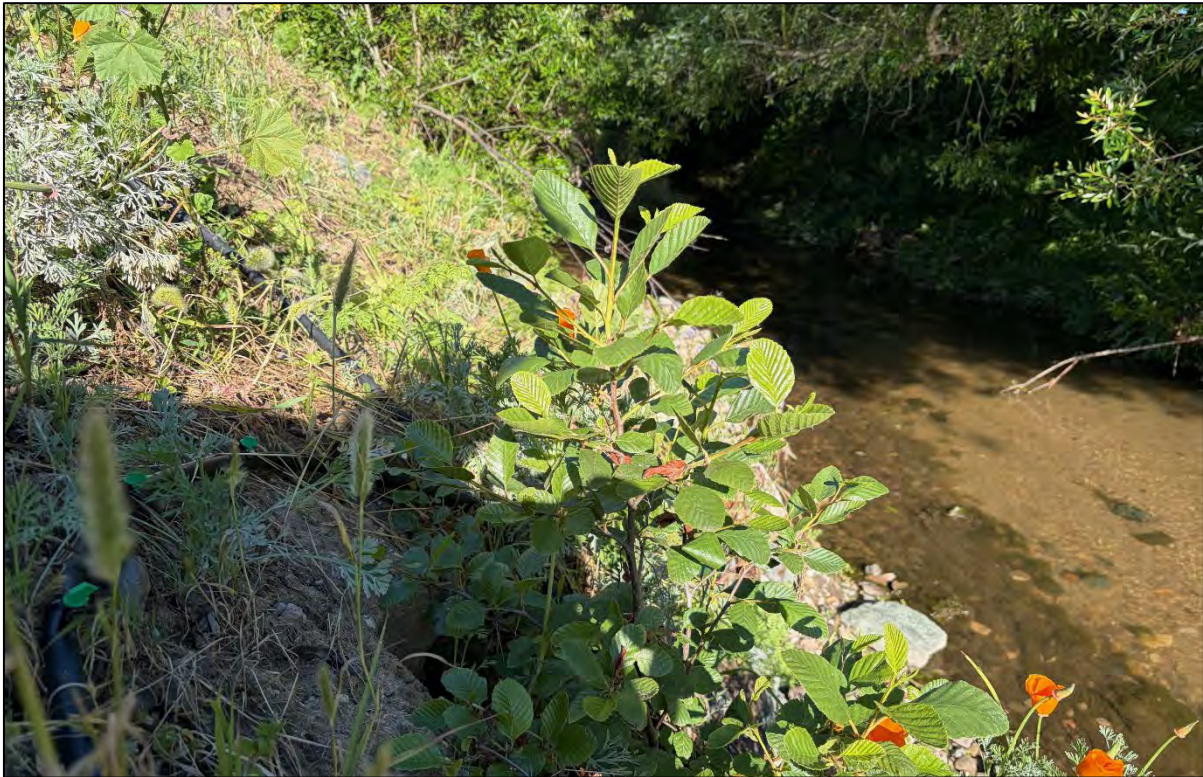
**Photograph 45.** California sycamore at the Breach Site planting area, facing east. April 14, 2026.

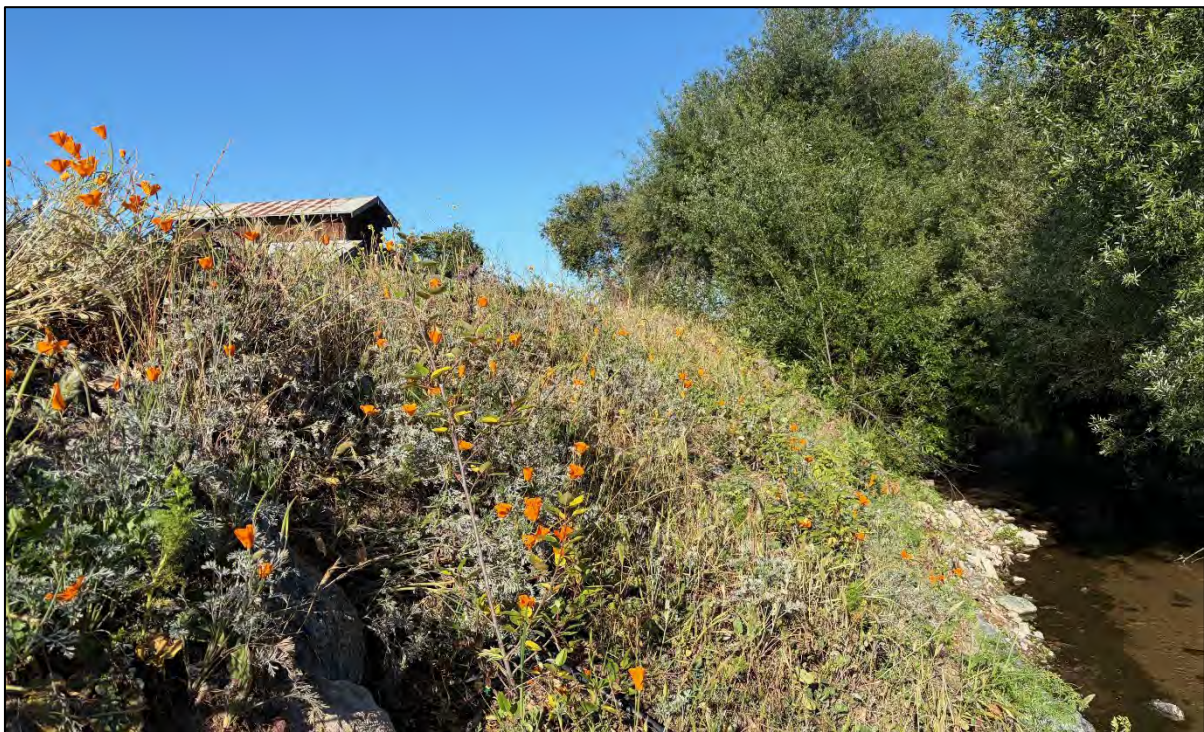
**Photograph 47.** Black cottonwood at the Breach Site planting area, facing east. April 14, 2026.
